Manhole Inspection Summary

Manhole # S37CC_004MH

Insp Date: **3/27/08 10:50 AM**

Location Address: **521 EAGER ST**

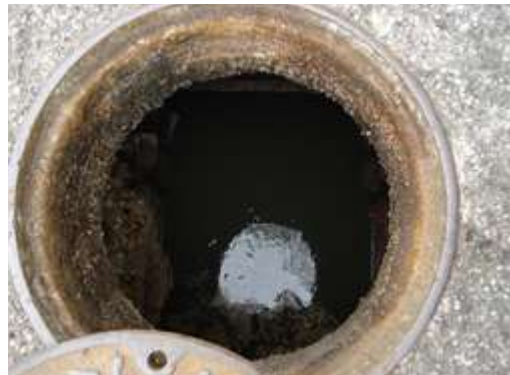
Defect 3

☒ **Evidence Of Surcharge**

Depth: **10** (ft.)

EVIDENCE OF SURCHARGE

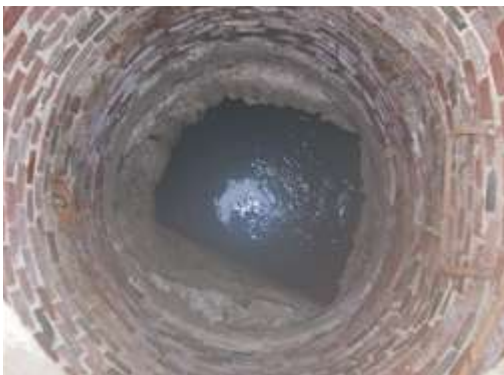
Defect 2

Condition: ☐ Sound ☒ **Cracked** ☐ Root Intrusion ☐ Loose Brick ☐ Deteriorated

Count: **4** Missing: **0** ☒ **Corroded**

STEPS CORRODED/CRACKED
CORBEL

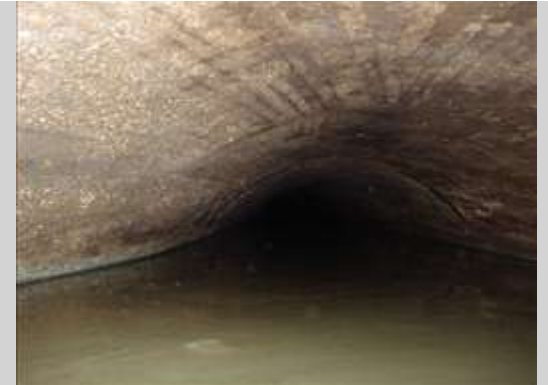
12 O'Clock Outflow

72 in. Circular Gravity Sewer
Pipe Out @ 12 O'Clock

Deposits: ☐ None ☐ **Mud** ☐ Sludge ☒ **Debris** ☐ Grease

Silt Depth: **18** (in.) Deposits Extent: **Light**

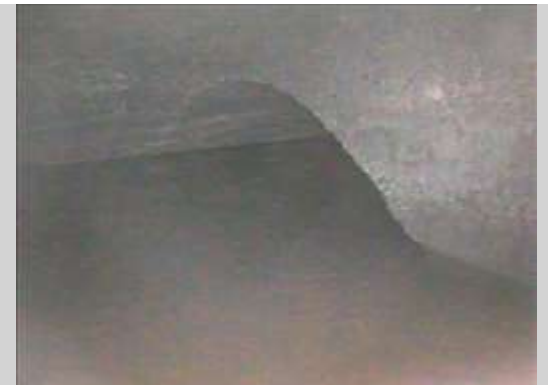
6 O'Clock Inflow

72 in. Circular Gravity Sewer
Pipe In @ 6 O'Clock

Deposits: ☒ None ☐ **Mud** ☐ Sludge ☐ Debris ☐ Grease

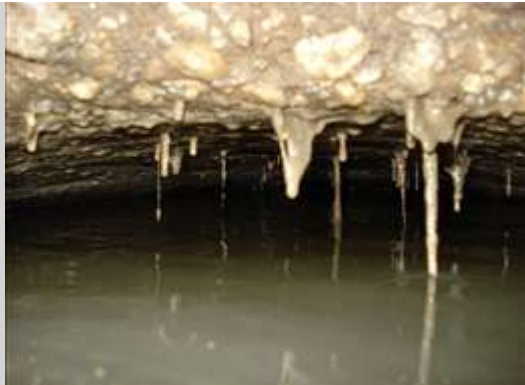
8 O'Clock Inflow

72 in. Circular Gravity Sewer

Pipe In @ 8 O'Clock

Deposits: ☐ None ☒ **Mud** ☐ Sludge ☐ **Debris** ☐ Grease

Silt Depth: **38** (in.) Deposits Extent: **Medium**

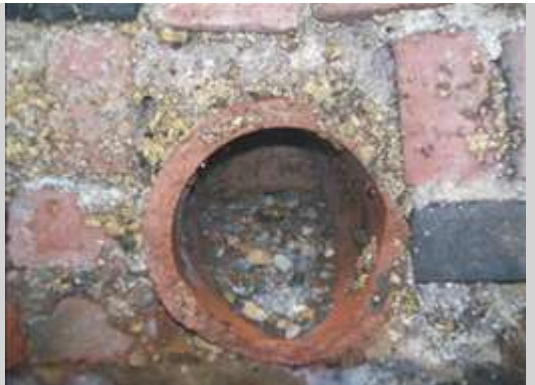
9 O'Clock Inflow

6 in. Circular Gravity Sewer

Pipe In @ 9 O'Clock

Deposits: ☐ None ☐ Mud ☐ Sludge ☒ **Debris** ☐ Grease

Silt Depth: **3** (in.) Deposits Extent: **Heavy**

Connects To: **Stub connection / abandoned**
